## Photo Keys

9.15.2023

## **PHOTOS INCLUDED BY PHOTO KEY:**

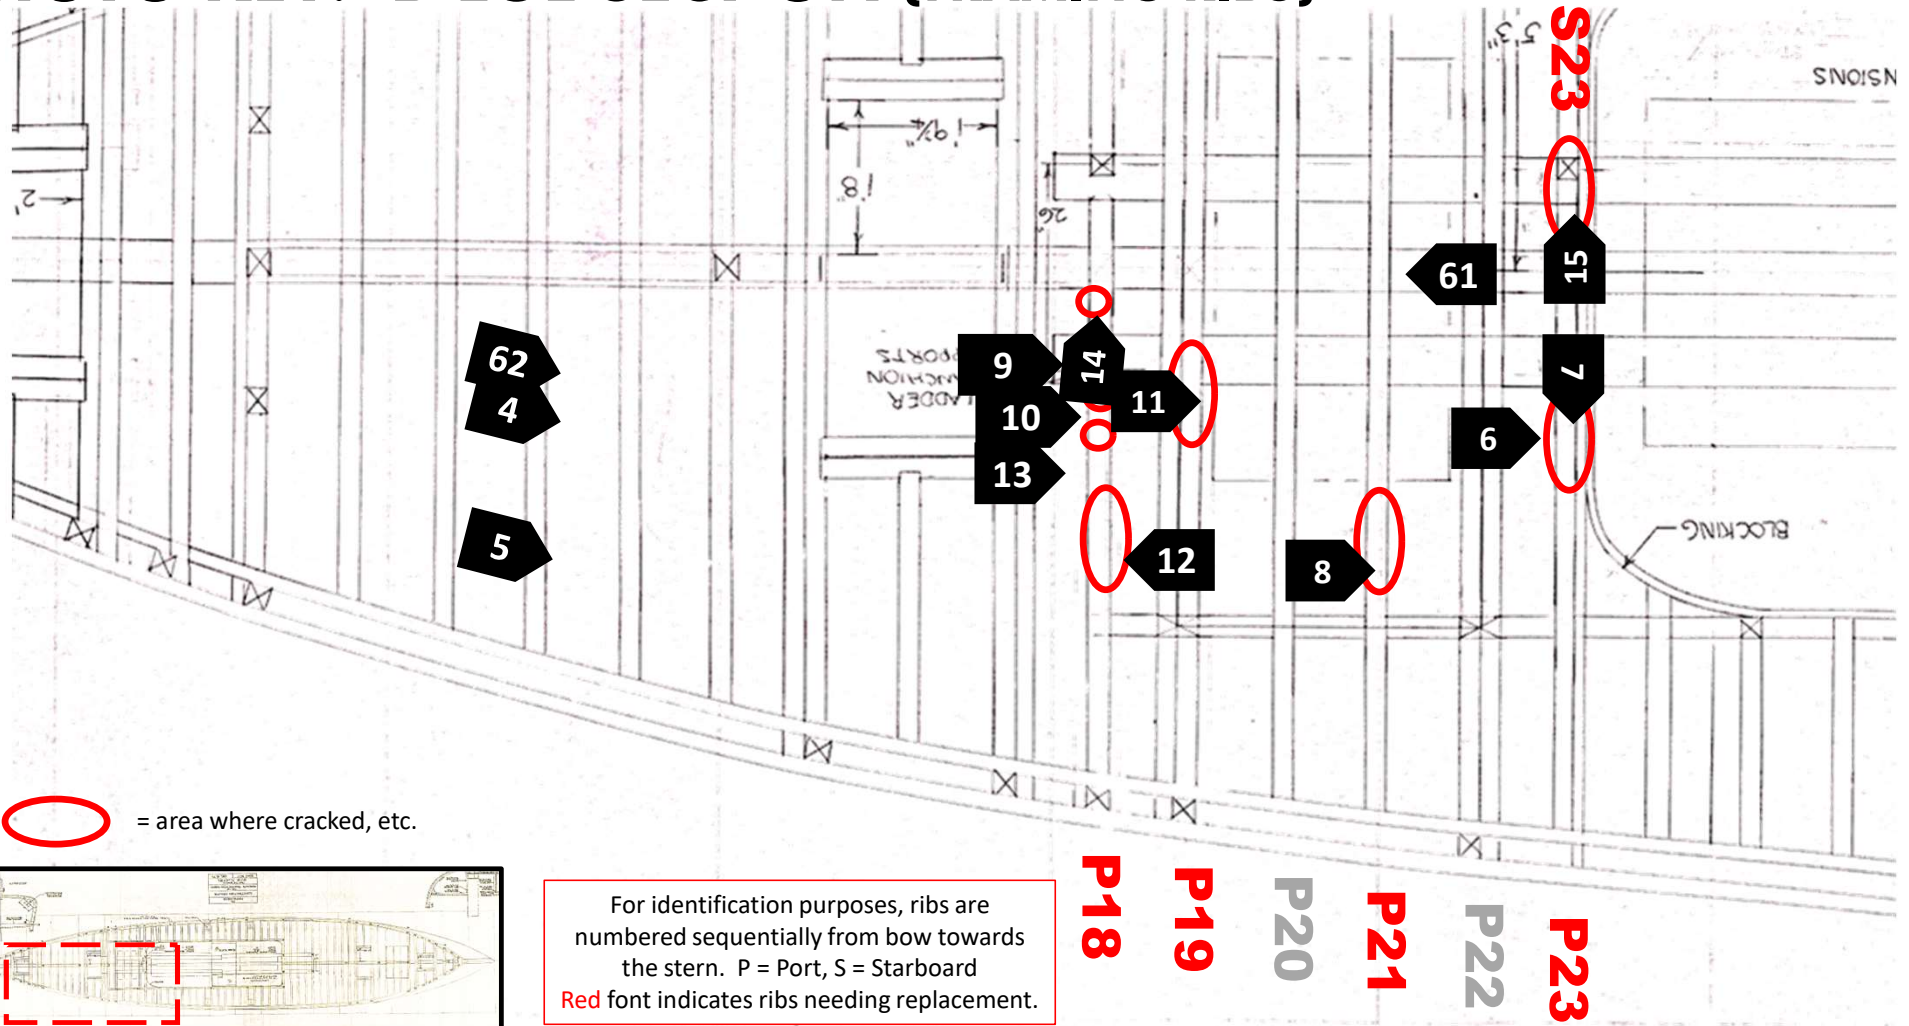
# PHOTO KEY: BILGE SECTION (FRAMING RIBS)

**NOTE:** December 1992 Hull Framing Plan from *Minnehaha* Restoration (1990-1996). Construction of the hull has not changed since restoration.

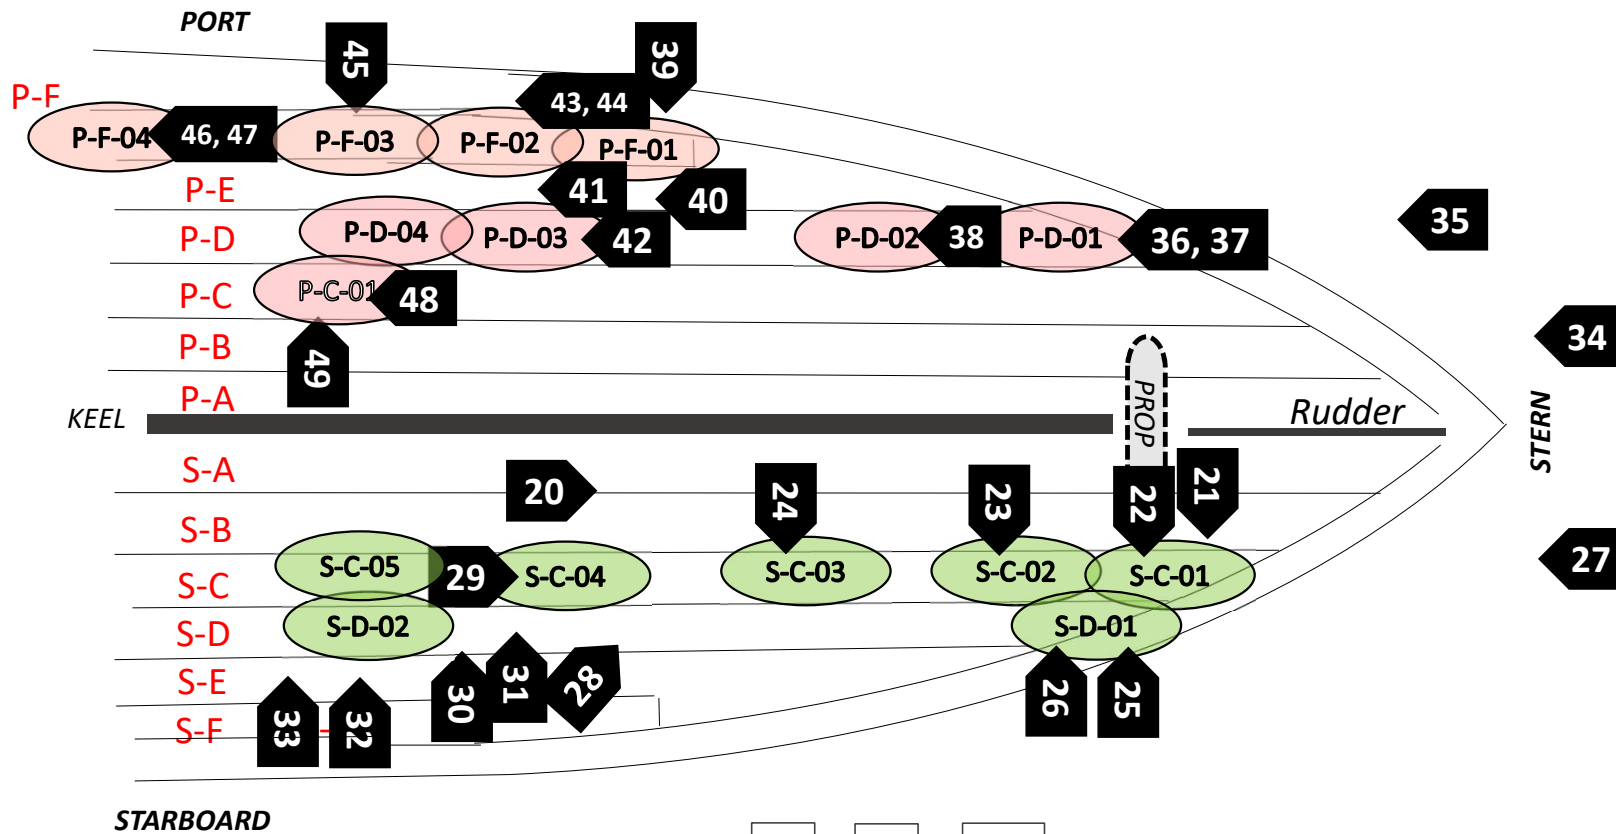
# PHOTO KEY: HULL SECTION (BOTTOM PLANKS)

Port Bottom Planks	
Rot Area	Photo #'s
P-C-01	48, 49
P-D-01	34, 35, 36, 37
P-D-02	34, 35, 38
P-D-03	40, 41
P-D-04	41
P-F-01	35, 39
P-F-02	35, 40, 41, 43, 44
P-F-03	41, 42, 43, 44, 45
P-F-04	46, 47

Starboard Bottom Planks	
Rot Area	Photo #'s
S-C-01	20, 21, 22
S-C-02	20, 23, 25, 27
S-C-03	20, 24, 27
S-C-04	27, 28, 29, 30, 31
S-C-05	30, 32, 33
S-D-01	20, 25, 26, 27
S-D-02	27, 30, 32
